Manhole Inspection Summary

Manhole # S57M__026MH

Location Address: **3901 dillon st**

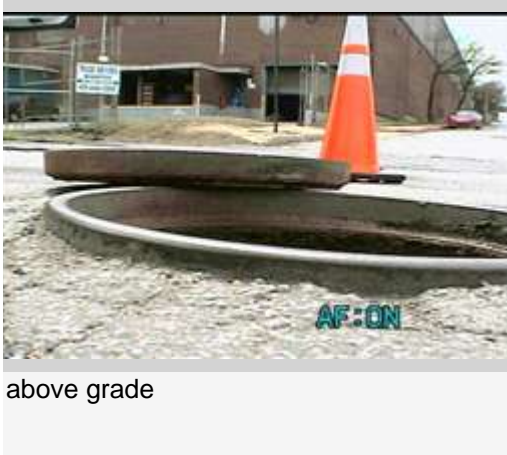
Defect 2

Diameter: **26** (in.) Length: **0** (in.) Dist A/B Grade: **2** (in.)

above grade

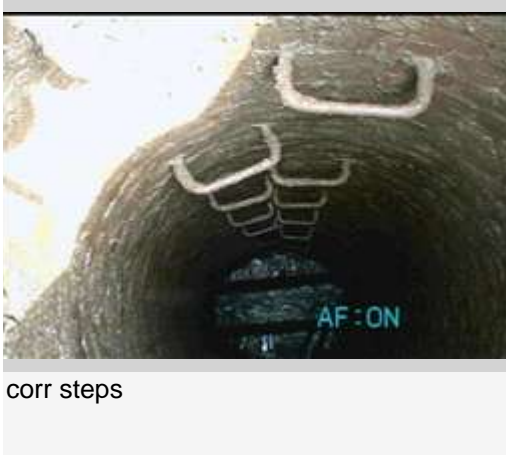
Defect 1

Count: **14** Missing: **0** ☒ **Corroded**

corr steps

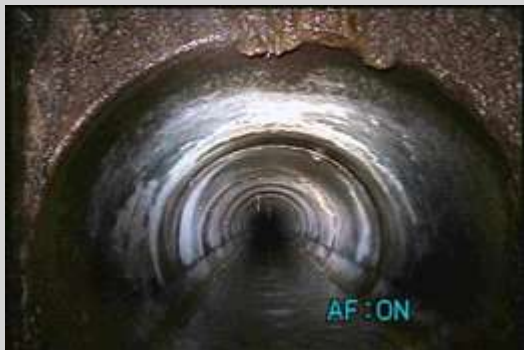
12 O'Clock Outflow

27 in. Circular Gravity Sewer
Pipe Out @ 12 O'Clock

Pipe Material: **Clay** ☐ Pipe Lined

Invert Depth: **24.00** (ft.) Flow Characteristics: **Fast**

Deposits: ☒ None ☐ Mud ☐ Sludge ☐ Debris ☐ Grease

Infiltration: **None** Pipe Seal Cond: **Unknown**

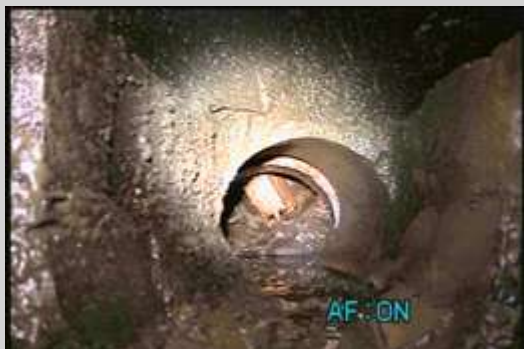
3 O'Clock Inflow

8 in. Circular Gravity Sewer
Pipe In @ 3 O'Clock

Deposits: ☐ None ☐ Mud ☐ Sludge ☒ **Debris** ☐ Grease

Silt Depth: 8 (in.) Deposits Extent: **Heavy**

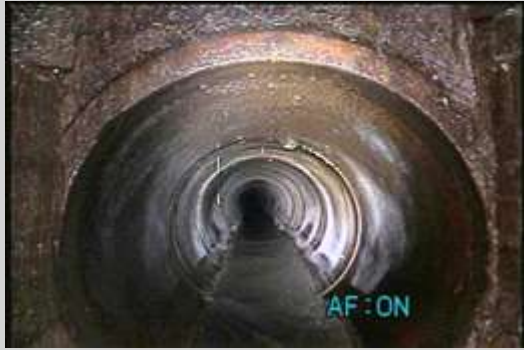
6 O'Clock Inflow

27 in. Circular Gravity Sewer
Pipe In @ 6 O'Clock

Pipe Material: **Clay** ☐ Pipe Lined

Invert Depth: **23.83** (ft.) Flow Characteristics: **Fast**

Deposits: ☒ None ☐ Mud ☐ Sludge ☐ Debris ☐ Grease

Infiltration: **None** Pipe Seal Cond: **Unknown**
